Airmaster Propellers Ltd

SERVICE BULLETIN

APL-SB-11

**SUBJECT: SEALING OF BLADE ASSEMBLIES TO
PREVENT WATER INGRESS INTO HUB**

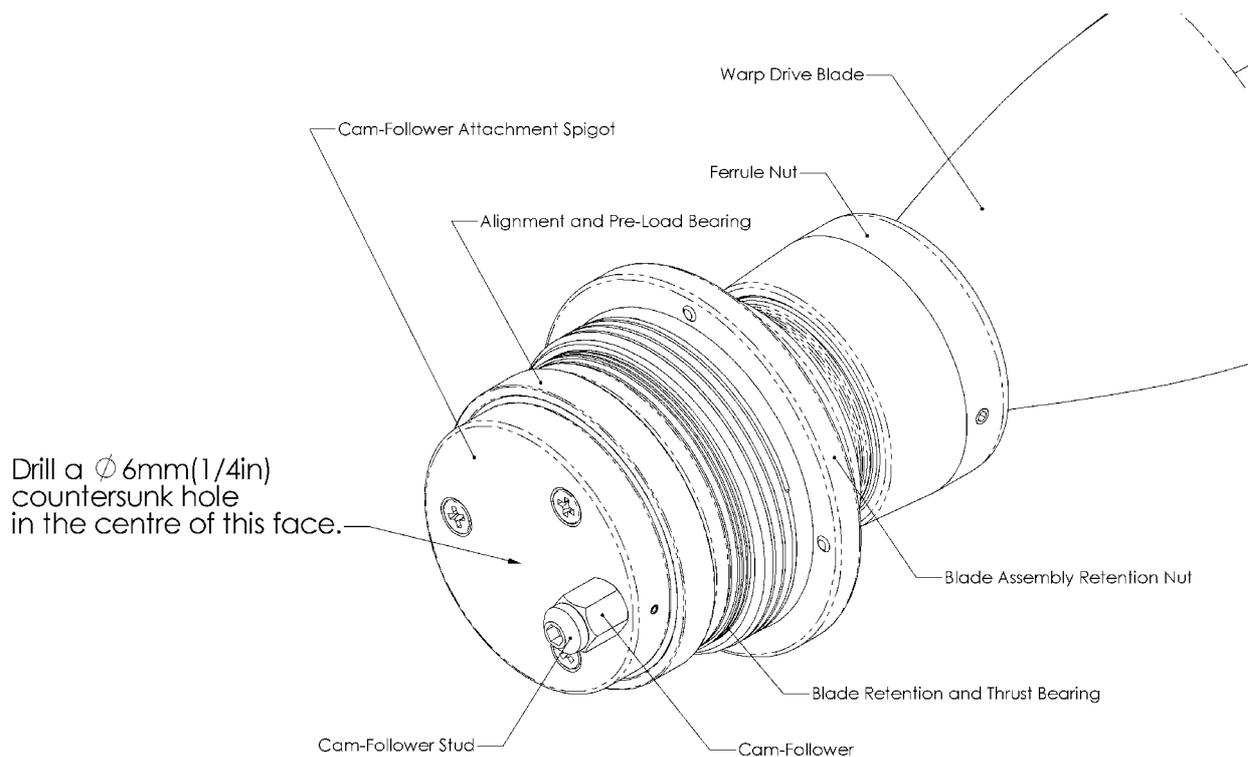
Figure 1 - Blade Assembly showing Required Location of Countersunk Hole

1. Airmaster AP332 propellers may suffer from water ingress while the propeller is stationary. Water, such as that from rain, is known to be able to enter the blade assembly through the annular gap between the shank of the Warp Drive blade and the ferrule nut. The water then passes down the two gaps between the blade retention sleeves and enters a cavity enclosed by the blade, the blade ferrule and the cam-follower attachment spigot. From this cavity water is able to enter the propeller hub, primarily by passing through the hole for the small spring-pin that retains the cam-follower stud.
2. This service bulletin addresses sealing of this blade cavity and the paths that allow movement of water from the cavity to the propeller hub.

6. Drill a 6mm (1/4in) hole in the centre of the inboard face of the cam-follower attachment spigot as indicated in the following diagram. Material thickness at this point is 4mm of aluminium before the drill bit will enter a cavity. Countersink the hole to ensure a smooth edge, as this face of the cam-follower attachment spigot is a sliding surface against the plastic pitch change slide.
